USABAAR

OH-58 ACCIDENT SUMMARY

May 1969 through February 1971

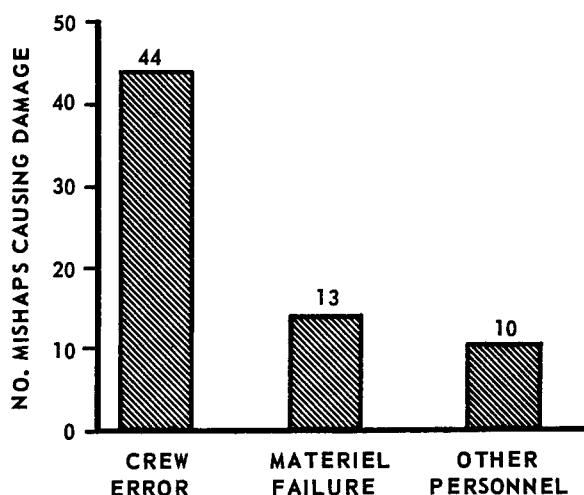
DISCUSSION. Figure 1 depicts graphically, by cause, 67 of the 202 OH-58A mishaps in which damage was incurred. As can be readily seen, crew error caused the preponderance of these 67 mishaps in which 17 fatalities and 15 injuries occurred. Crew error was listed as the cause factor in all of the fatal accidents and in 22 of the 37 incidents. Except for one injury, all injuries and fatalities occurred in the major accidents.

FIGURE 1
OH-58A Mishaps Resulting In
Damage Shown By Cause Factors

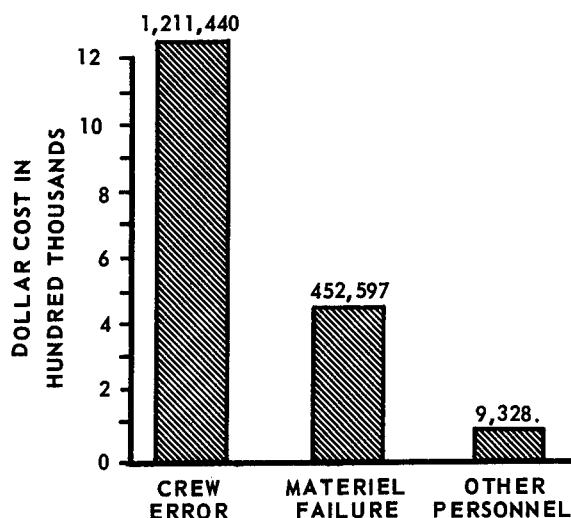
FIGURE 2
Mishap Costs

Figure 2 depicts the cost breakdown of the 67 mishaps by cause factors. Although secondary in significance by far to the loss of life, the loss in dollars sustained in both the fatal and

nonfatal mishaps is staggering. The OH-58A mishaps reported during this period cost the taxpayer approximately \$1,674,000. About 72 percent of this cost, or about \$1,212,000, was incurred in crew-error caused mishaps.
